Effect of Jacket Bond Failure Mode on the Corrosion of Buried Telecom Cables

Considering shielding-to-jacket failure mode during design helps protect the ECCS steel in plastic-coated metal shielding tapes against future corrosion and cable failure.

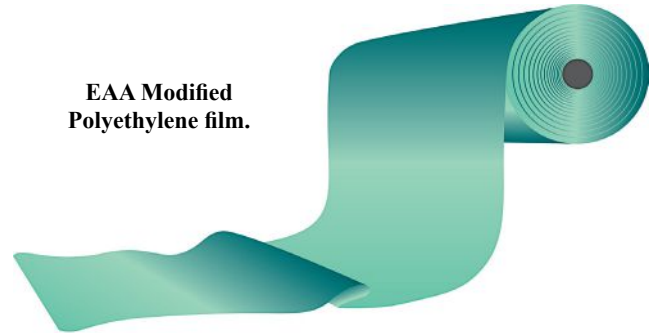
EAA Modified Polyethylene film.

the ECCS shield is laminated with film to further protect the steel. Copolymer ethylene and acrylic acid (EAA) film is used to protect the ECCS steel from moisture and chemical attack. The film not only protects the steel, but when sealed at the shielding overlap, prevents moisture penetration into the cable's core. The subsequent shield-to-jacket bond during the jacketing extrusion process creates a rigid sheath for added mechanical protection and prevents moisture ingress between the shielding and jacket. Considering this, cable wrap film must adhere to both ECCS steel and cable jacketing.

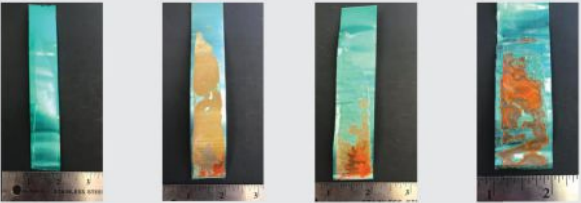
Figure 13 - LLFlex, Sample A, Sample B, and Sample C After Immersion in Acetic Acid

The results shown above and in Appendices D and E confirm that shielding with bare ECCS exposed is significantly more prone to corrosion than shielding designed with multilayers that exhibits intentional Interlayer Film Failure, like the LLFlex samples.

LLFlex	A	B	C
H ₂ O	10	6	4	1
CH ₃ COOH	10	1	3	1
NH ₄ OH	10	8	8	8
NaCl	9	1	8	5
NaOH	10	10	10	10
Average	9.8	5.2	6.6	5
